PSS

S h a f t S e a l

INSTALLATION INSTRUCTIONS

For Shafts : 4" to 6" (100 to 150mm)

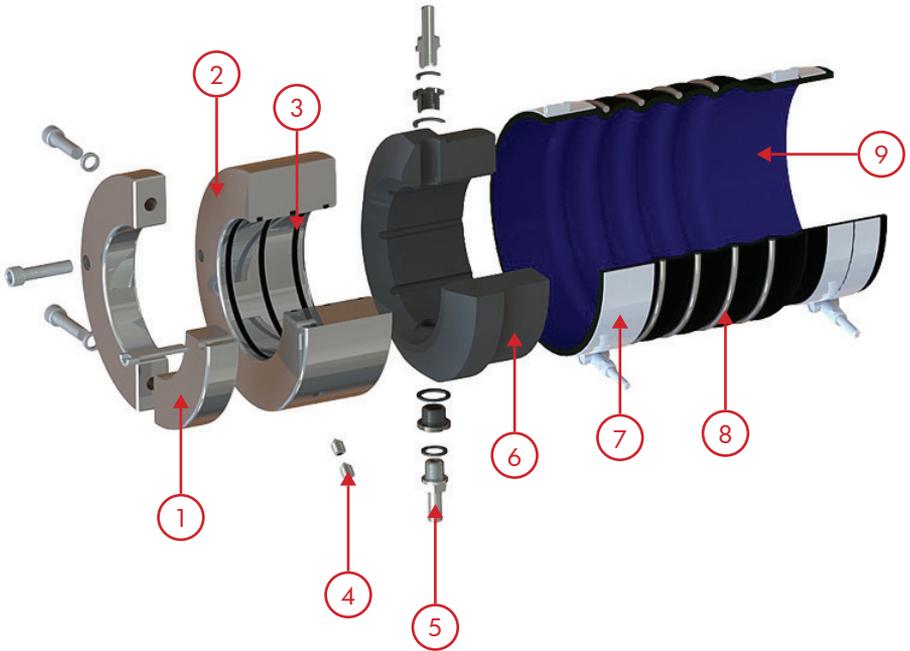
| 1. Clamp Collar | 6. Carbon Strator |
| 2. Rotor | 7. Clamps |
| 3. Nitrile O-Rings | 8. Steel Hoops |
| 4. Set Screws | 9. Bellow |
| 5. Hose Barb | |

1. Unbolt the shaft coupling from the transmission coupling.
2. Remove the shaft coupling from the shaft.
3. Remove the old stuffing box and all attached fittings. There are many stuffing box styles and types of attachment to the boat for these large shafts, so by this time you will have already checked with your PSS dealer for the PSS requirement at the stern tube end.
4. Clean the shaft with very fine sand paper or emery paper (400 to 600 grit), paying particular attention to the shaft key way to make certain there are no burrs or sharp edges that could tear the o-rings upon assembly.
5. Slide the open end of the bellow and two hose clamps over the shaft log. The carbon flange will already be securely attached to the bellow by 2 T-bolt style clamps.

6. Slide the stainless steel rotor onto the shaft. Only use a water-soluble lubricant like dish soap to help the rotor and o-rings slide easily. Do not use grease or oil! Make sure the o-rings are positioned in the grooves of the rotor (spare o-rings are provided) and that the locking clamp collar is not tightened to the Stainless Steel Rotor.

7. Re-attach the shaft to the shaft coupling and the shaft coupling to the engine using the manufacturer recommendations.
8. Position the bellow on the stern tube so the carbon is centered with the shaft. **Caution:** The forward end of the stern tube should not extend beyond the aft cuff of the bellow. Clamp the cuff of the bellow to the shaft log with the two stainless steel t-bolt hose clamps.

9. Start the stainless steel rotor down the shaft (side with holes drilled towards the engine) and slide down the shaft so the rotor just comes in contact with the carbon flange. Mark this “no load” position on the shaft just in front of the stainless steel rotor with a marker or tape as a reference point.

10. By sliding the stainless steel rotor further back down the shaft, **compress the bellow 1”** (the “no load” mark on the shaft is used as a reference to measure amount of compression). A special tool may be needed for this operation, as the bellows are fairly stiff. The installer can decide the tool required but in no case can this tool touch the working faces of the seal. To assist sliding the rotor down the shaft the installer can thread bolts (3/8” x 16) into the holes on the O.D. of the rotor. These bolts will make a “handle” to better grip the rotor. If the rotor tends to slide back on the shaft after compressing the bellow, use the provided set-screw and thread it into the hole that is tapped all the way through to the bore of the rotor (only one out the 4 holes is drilled and tapped all the way). This screw will **temporarily** hold the rotor in place while the clamp assembly is fit in front of the rotor. **Important: Back-off this set-screw once the clamp assembly is slid into position with the screws snug.**

11. Align the holes that are drilled and tapped in the clamp assembly with the holes drilled on the face of the rotor.
12. Fit the clamp assembly in front of the rotor assembly to the shaft, making sure that the driver screws will align with the holes in the face of the rotor. Secure clamp assembly to the shaft and make sure driver screws are inserted into the holes on the face of the rotor.

13. Check if the rotor runs true to the shaft using a dial indicator. A tolerance of 2,000th inch (.002”) is acceptable. If the rotor is not true to the shaft, align it by working with the locking assembly and a mallet.

14. The seal has two hose barb fittings that require water to be plumbed into the seal to cool and lubricate it. This water flow is required. If there is a shaft bearing in the stern tube limiting the exhaust of the water flow, the second barb fitting may be vented overboard to eliminate excess pressure. On a twin-screw application, if there is no shaft bearing in the stern tube, the second barb fitting can be used as a jumper between engines to assure water flow even if one engine is shut down. **This plumbing must be done respecting the rules of underwater plumbing.** The water can come from the engine cooling raw water system, from a pump or from a scoop. A maximum pressure of 10 PSI is allowed.
